Existing Conditions Summary

Study Objectives

- Evaluate existing corridor operations and safety
- Evaluate multimodal accessibility
- Identify improvement strategies to reduce congestion

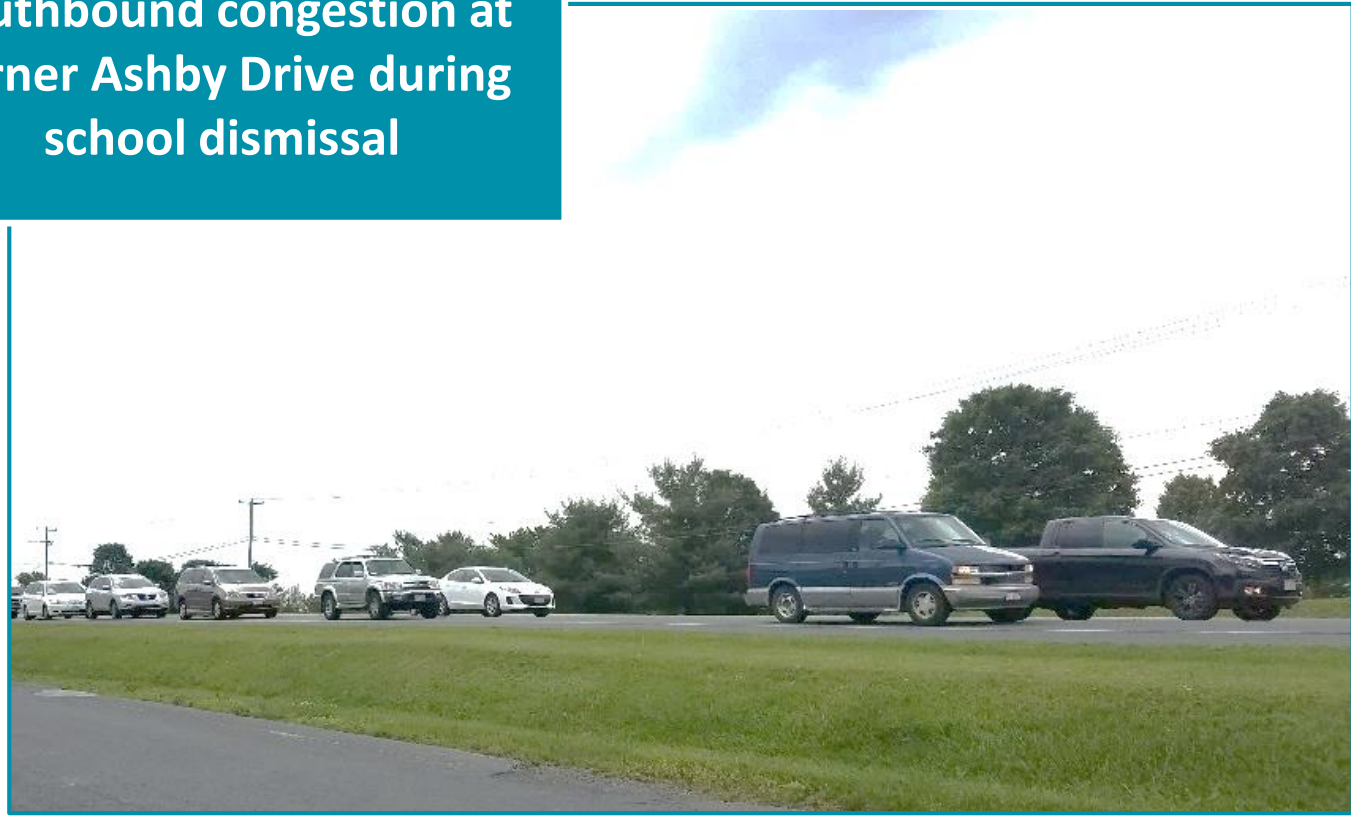
Southbound congestion at
Turner Ashby Drive during
school dismissal

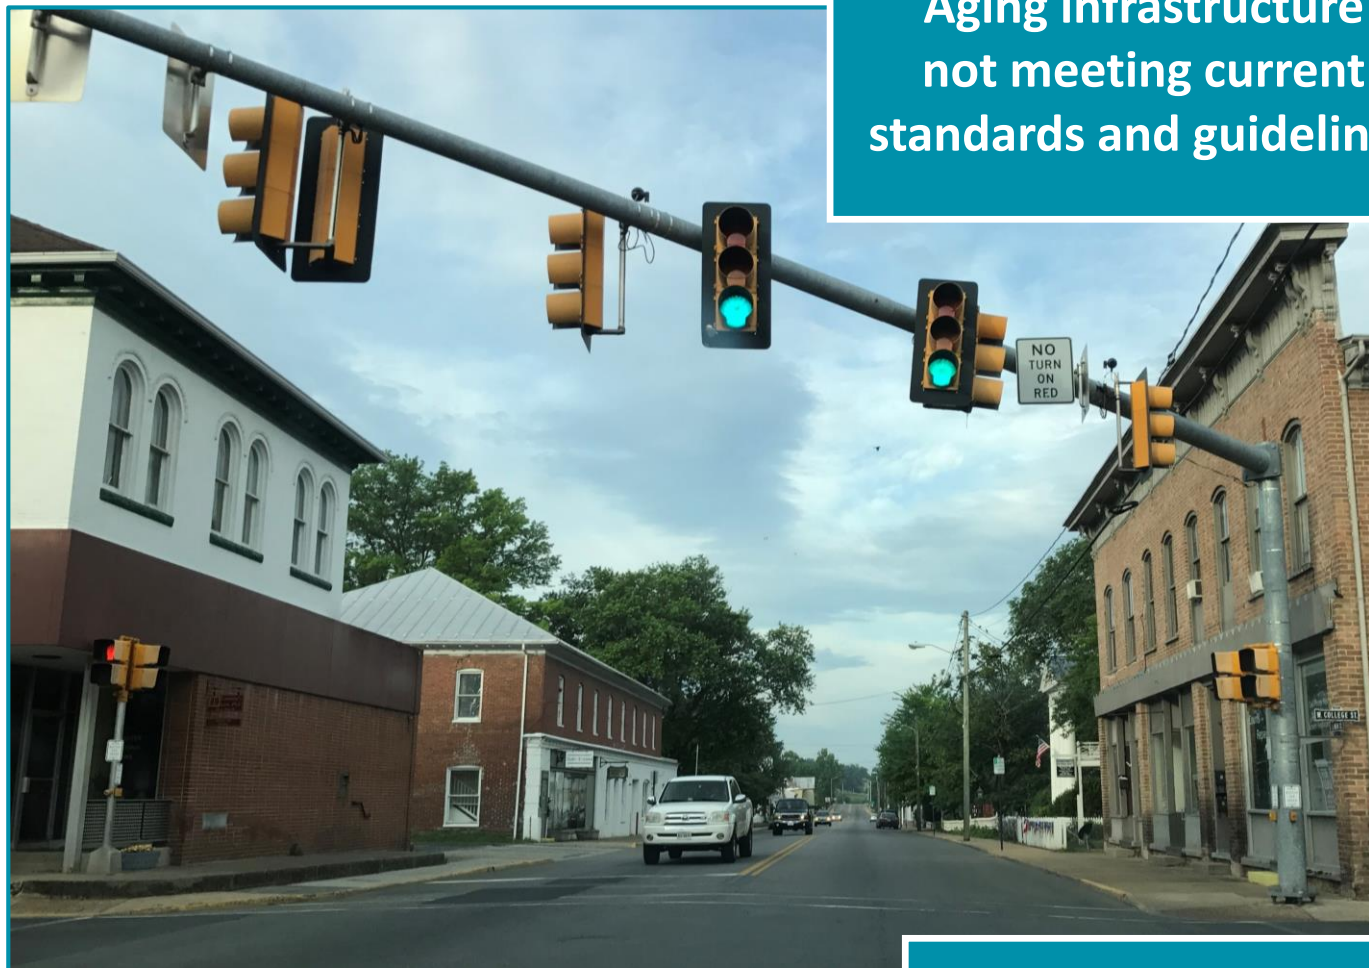
Aging infrastructure
not meeting current
standards and guidelines

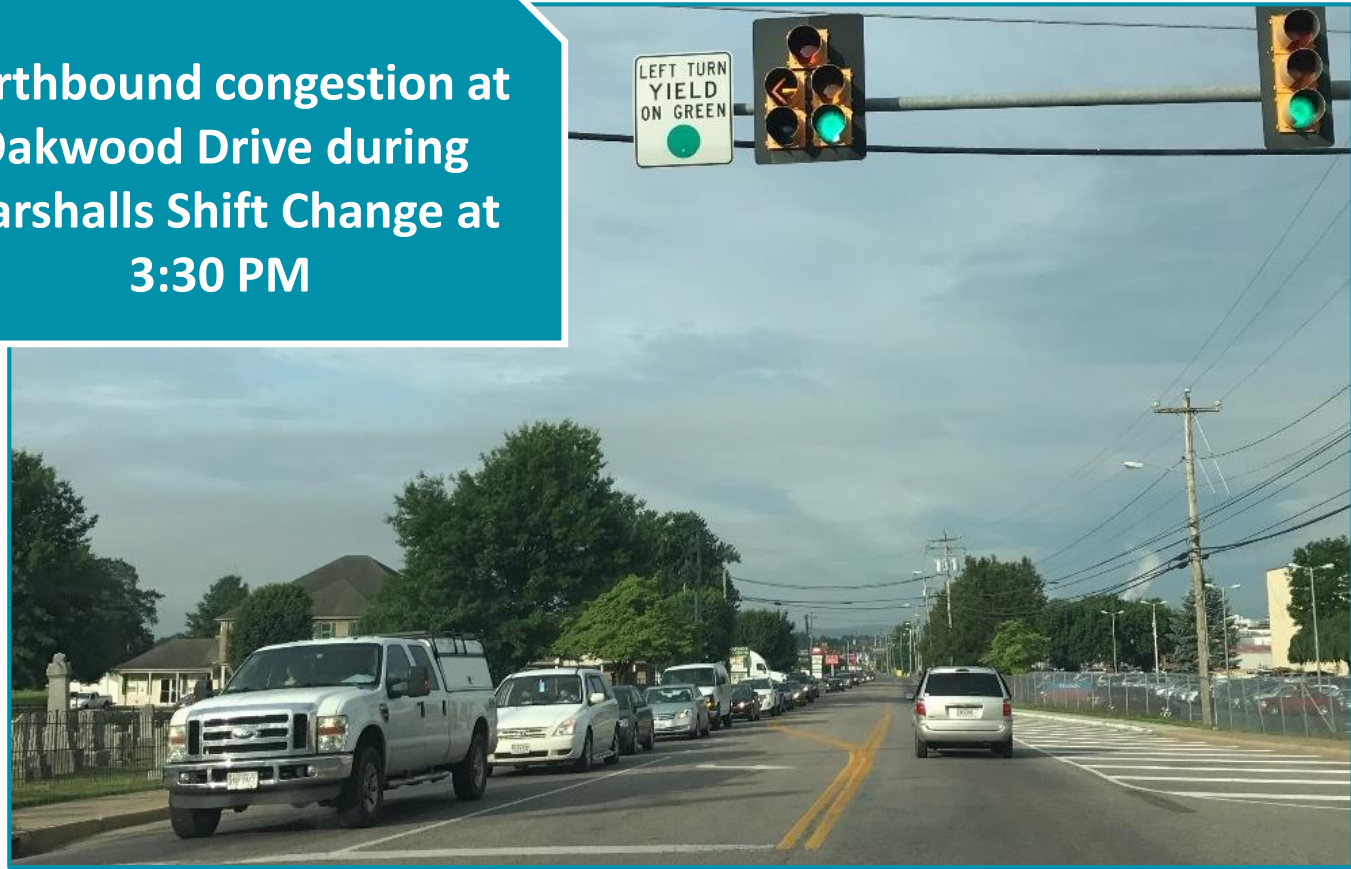
Northbound congestion at
Oakwood Drive during
Marshalls Shift Change at
3:30 PM

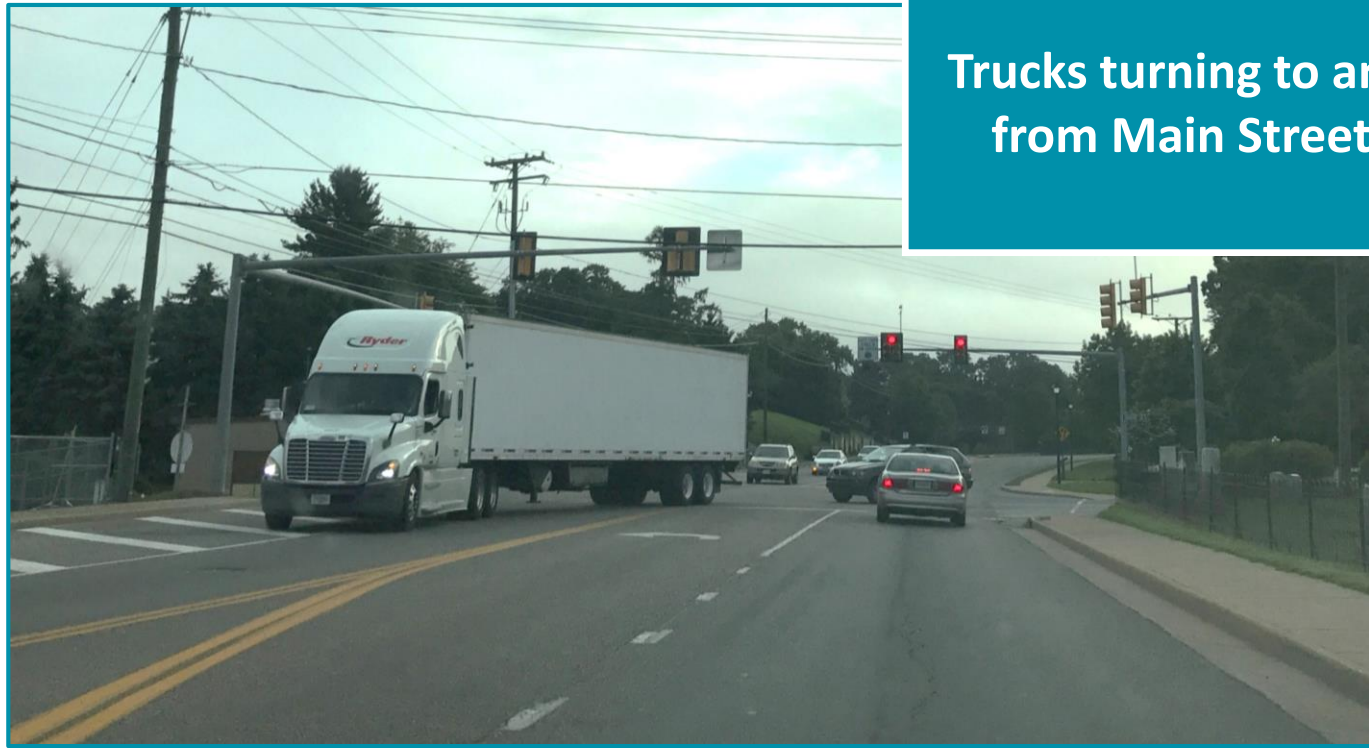
Trucks turning to and
from Main Street

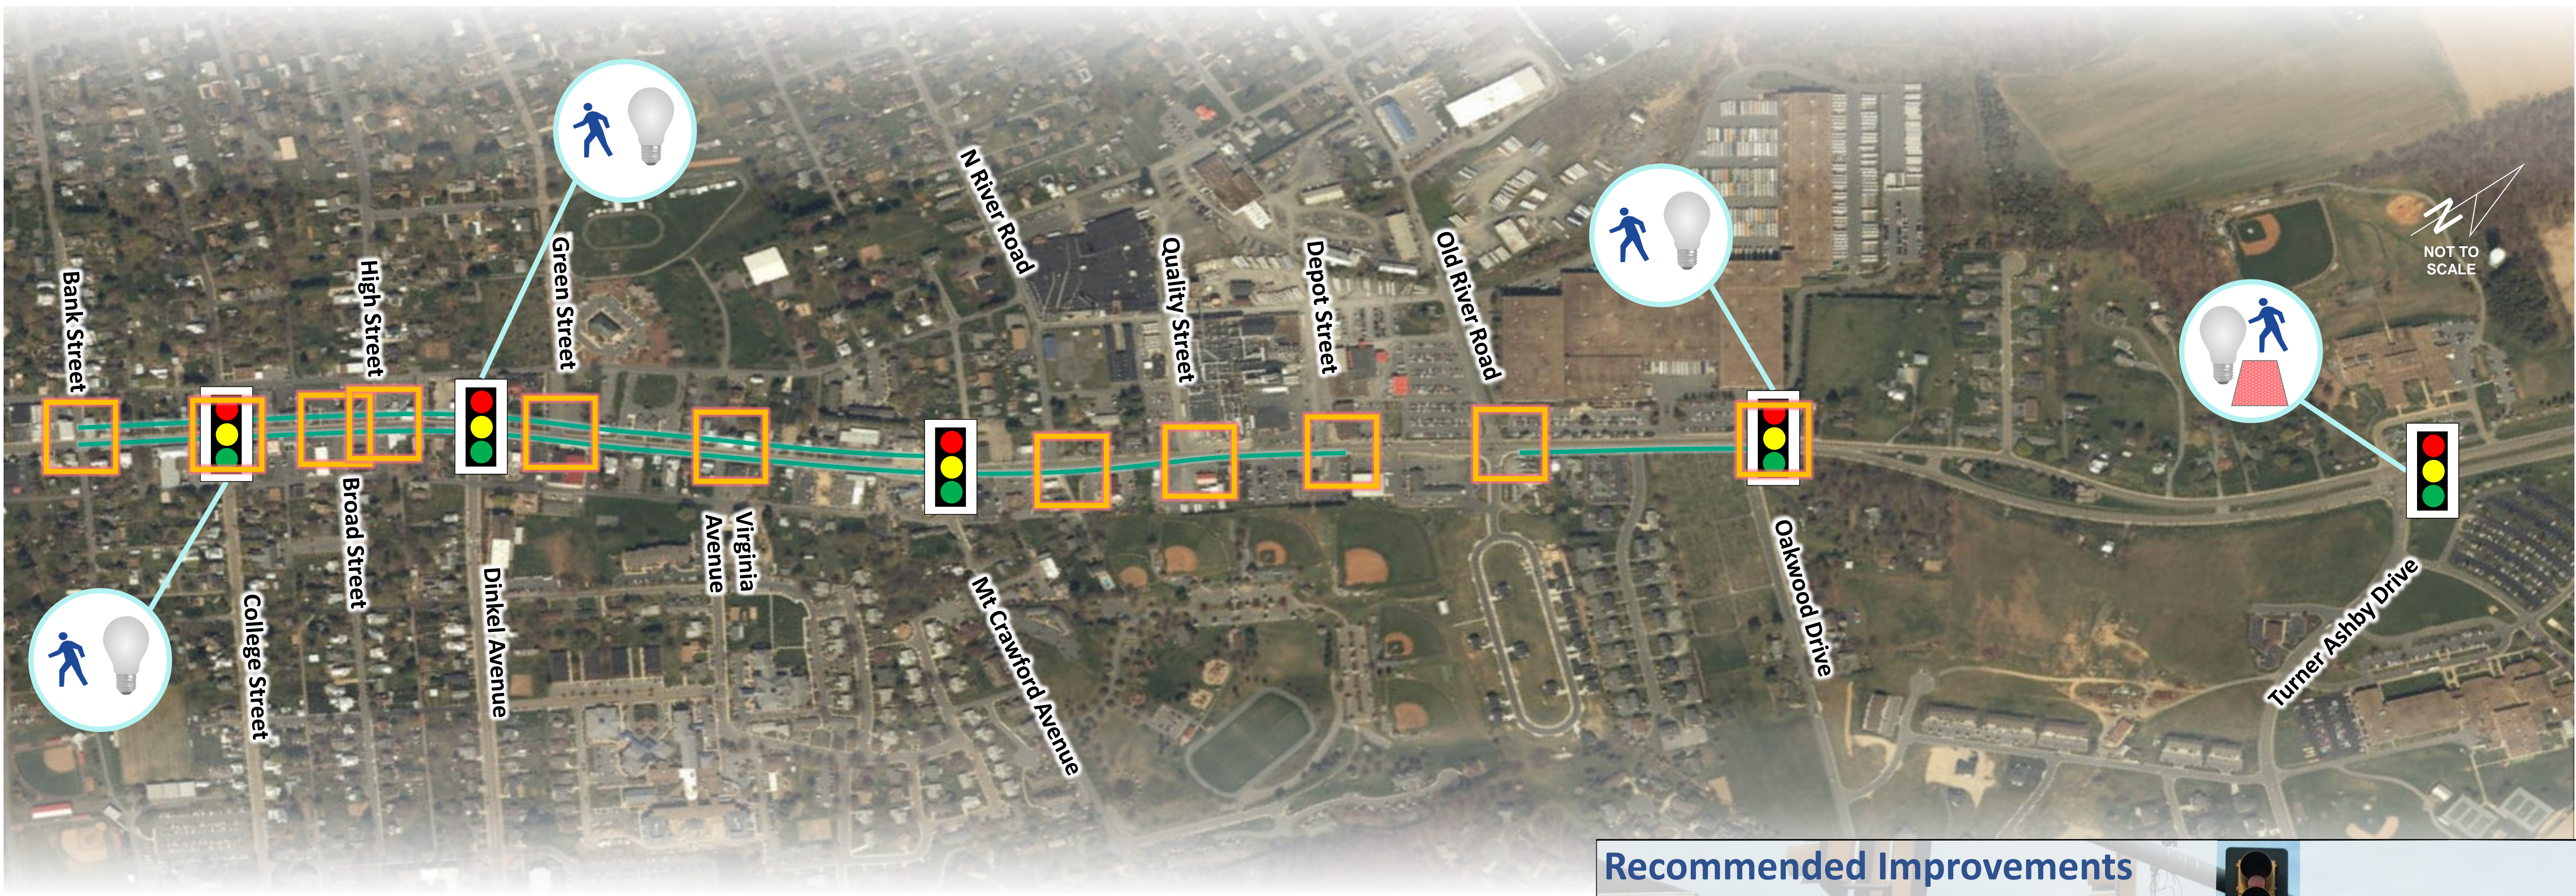
Existing Conditions

• Non-compliant sidewalk ramps
- Missing/faded crosswalk markings
- Missing/faded stop bar
-

- Non-compliant sidewalk ramps
-

- Missing/non-compliant pedestrian signals
-

- Incandescent vehicle signal displays
-

- No sidewalk buffer space

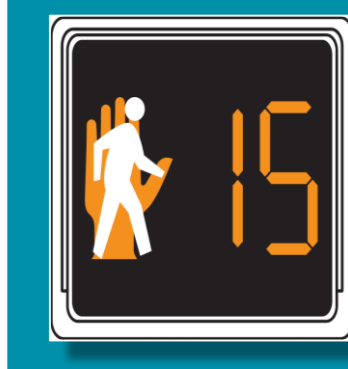
Pedestrian Signals

Distinguished walk and don't walk indications with countdown display

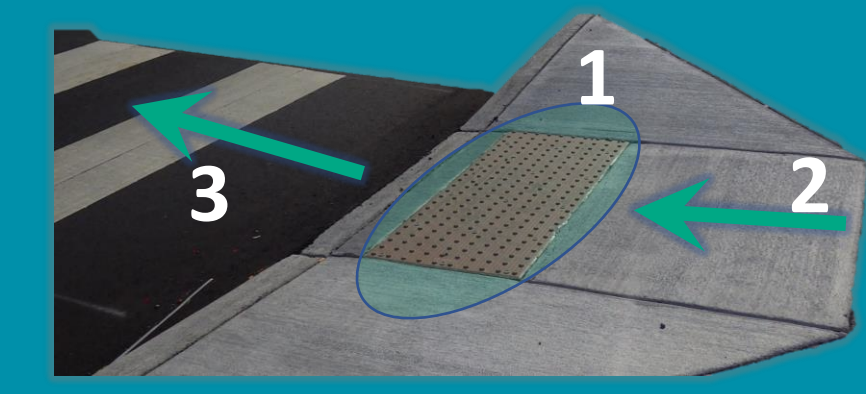
ADA Compliant Sidewalk Ramps

1. Tactile detectable warning surface
2. Appropriate ramp grade
3. Aligned with crosswalk

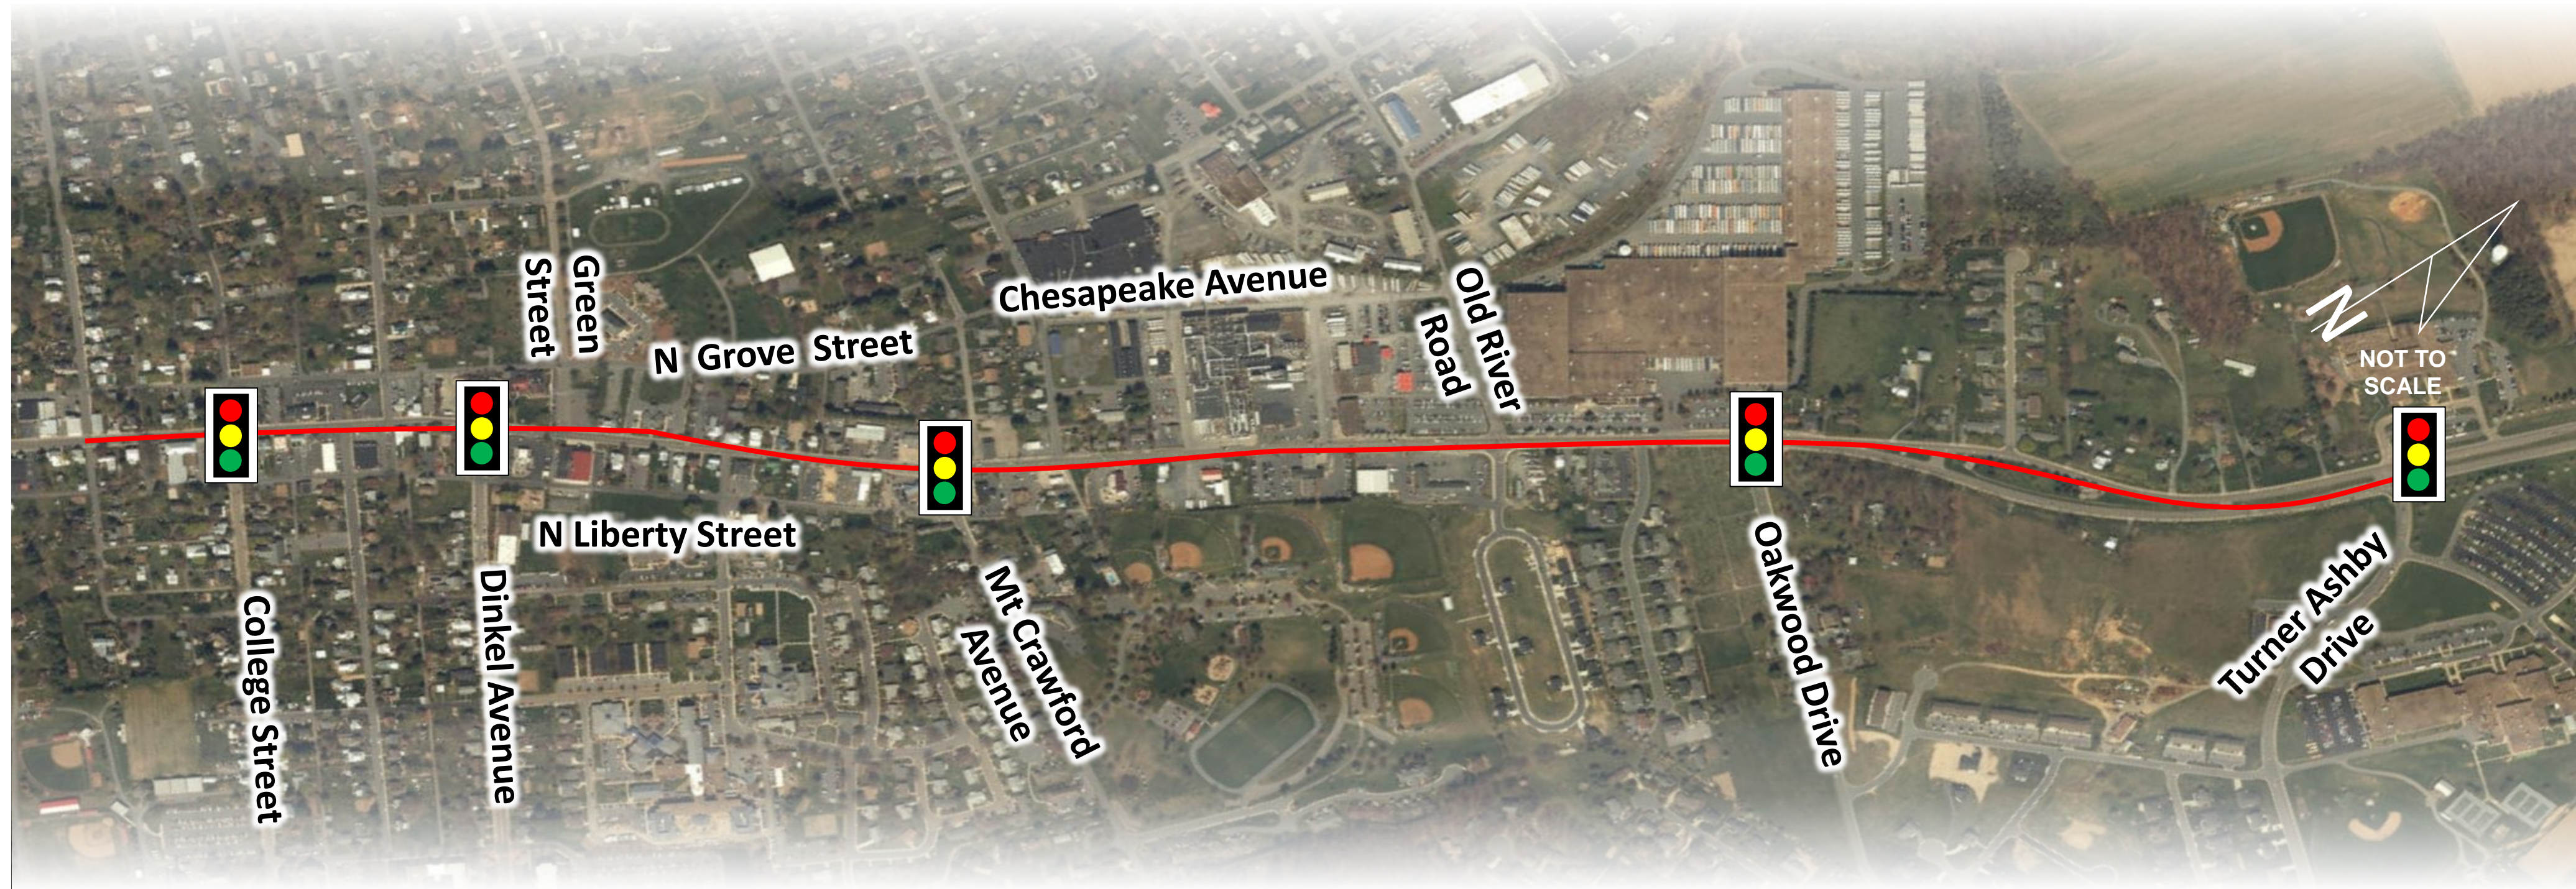
Existing Operations

Uncoordinated signal operations

- Can be more responsive to side street traffic
- Result in variable travel times along a corridor
- Present a greater potential for stop-and-go travel
- Typically result in longer delays compared to coordinated signal operations

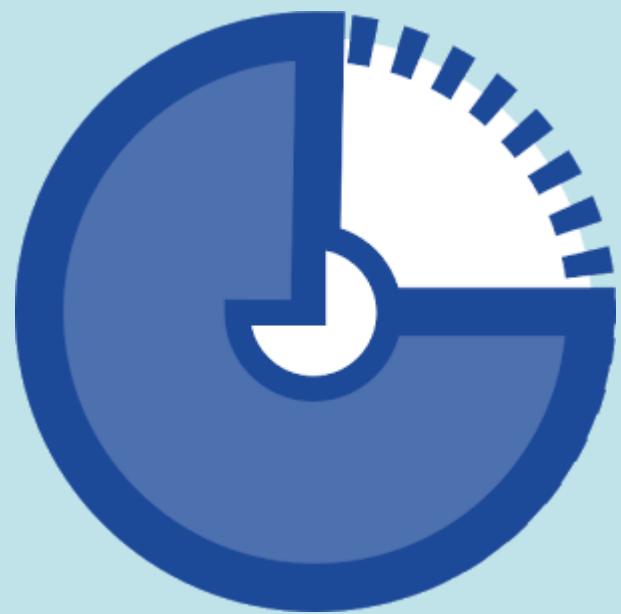
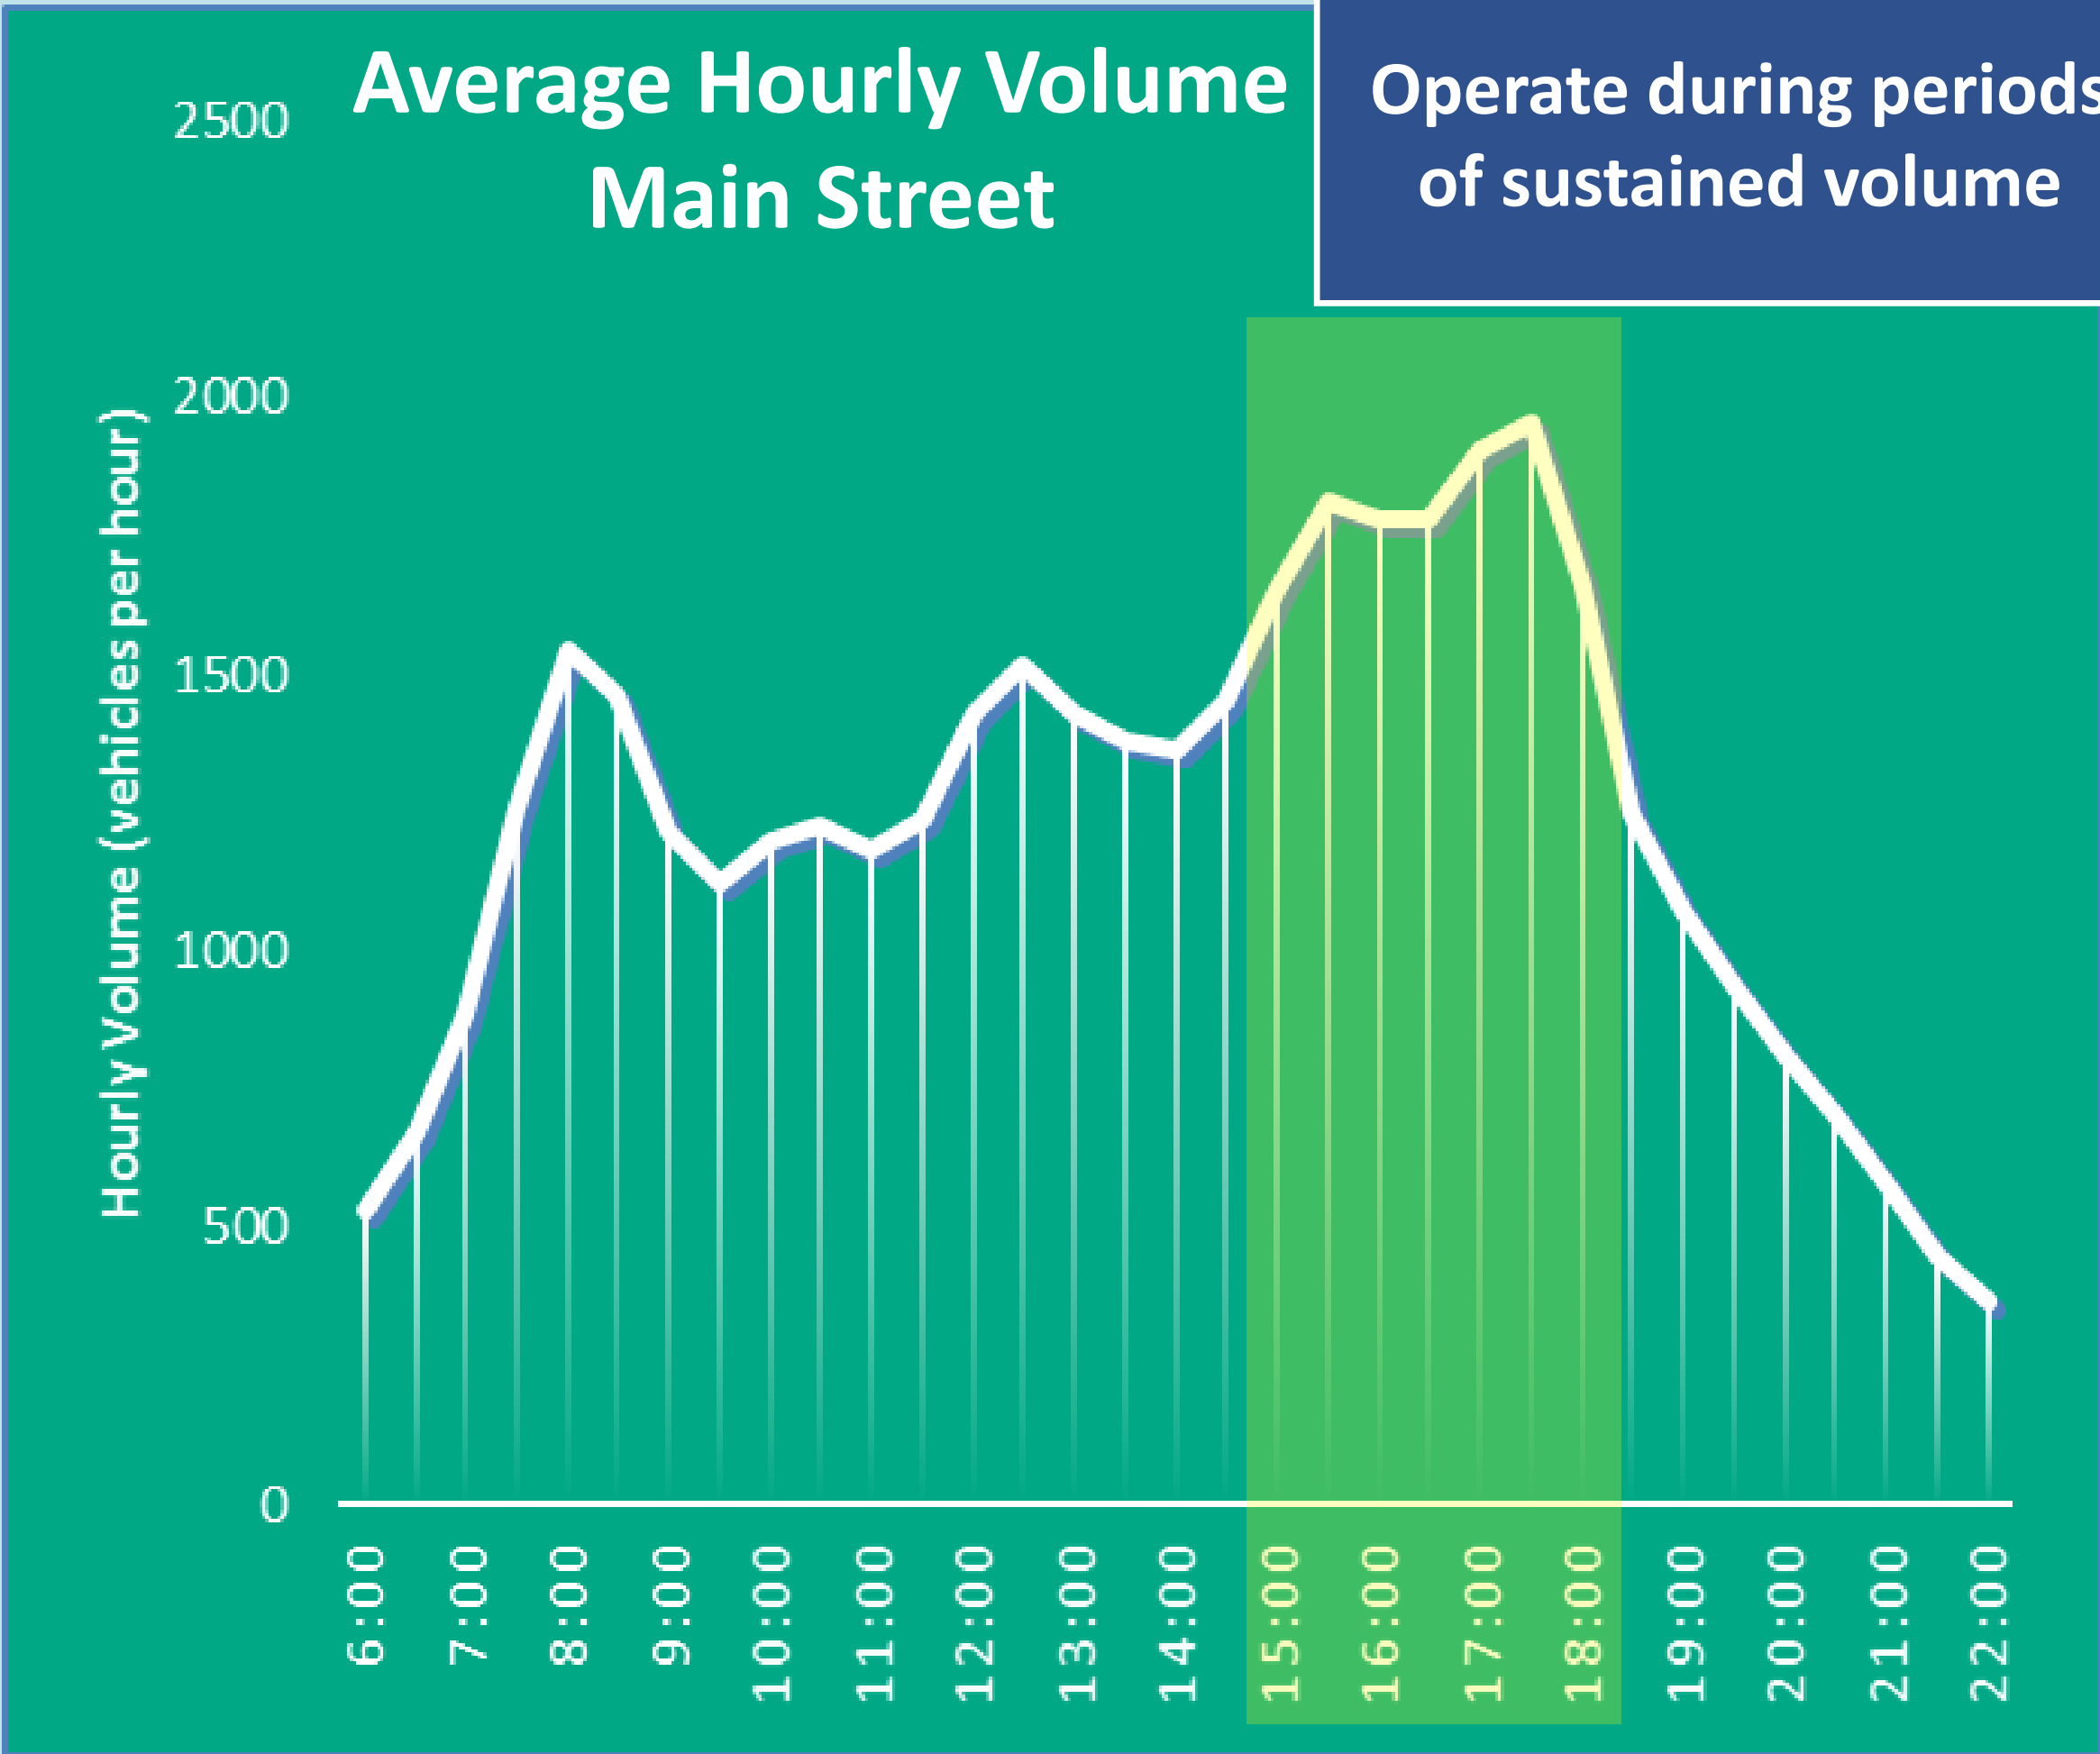
Recommended Operations

100 second cycle length

Allows for minimal Main Street stops while minimizing side street wait time

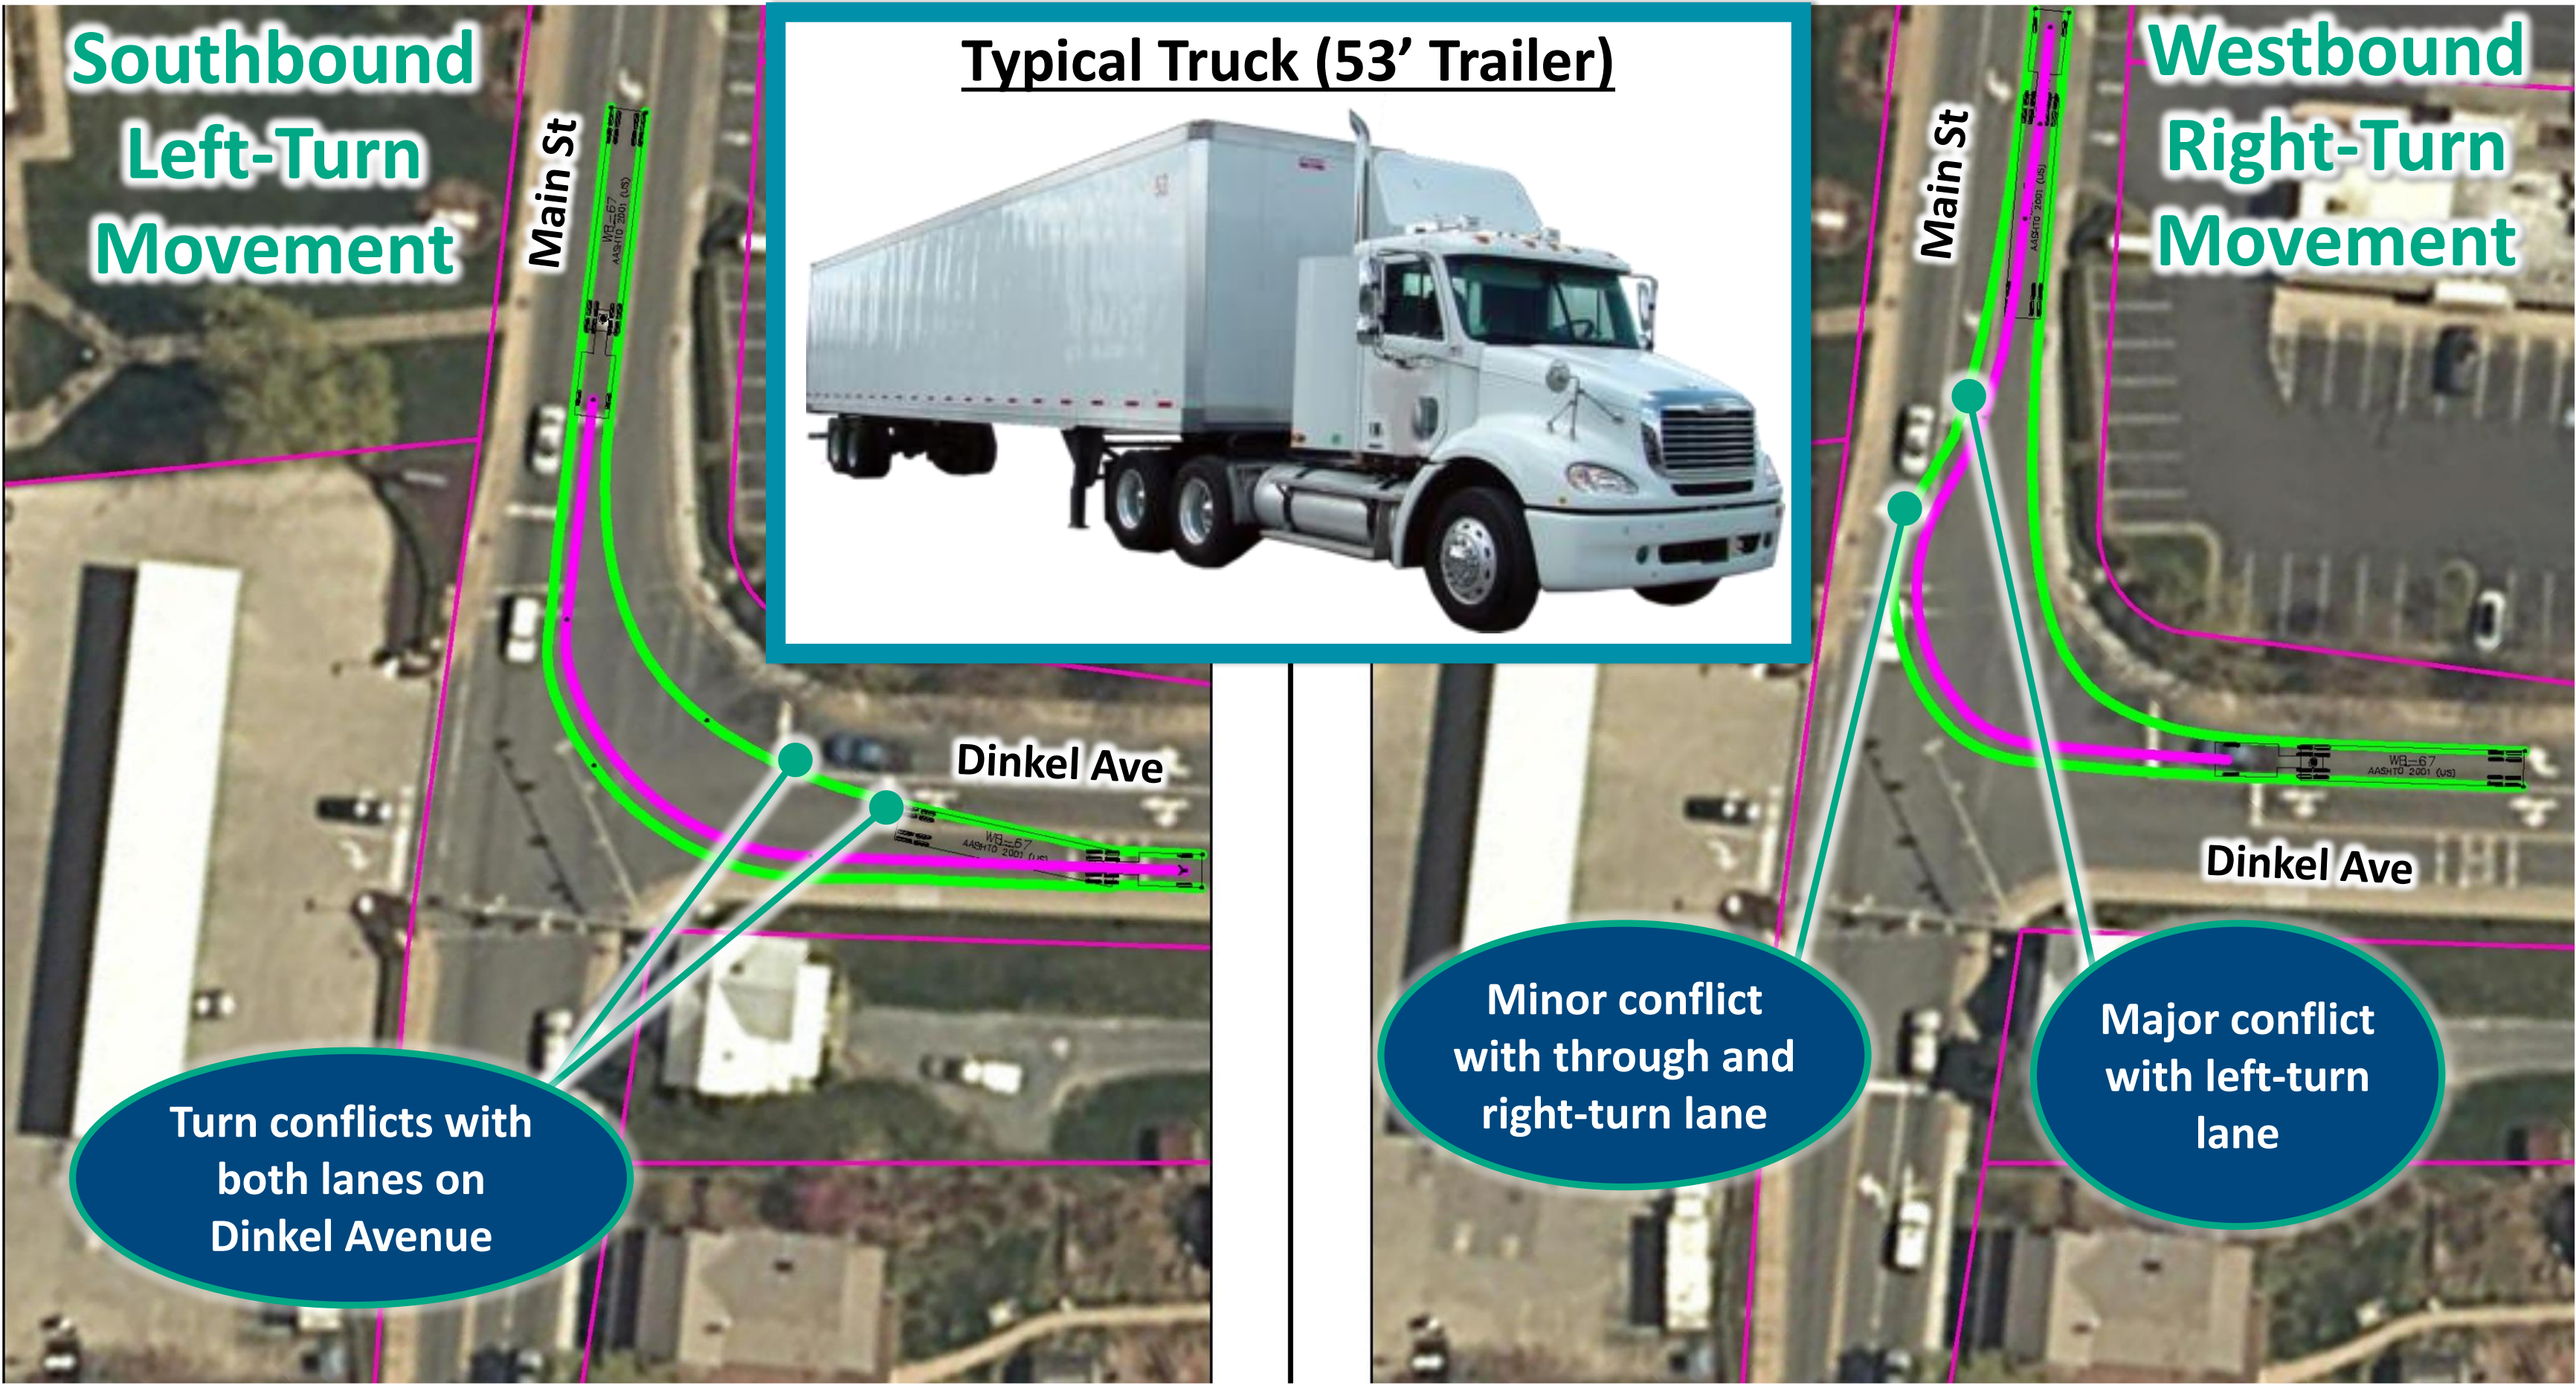
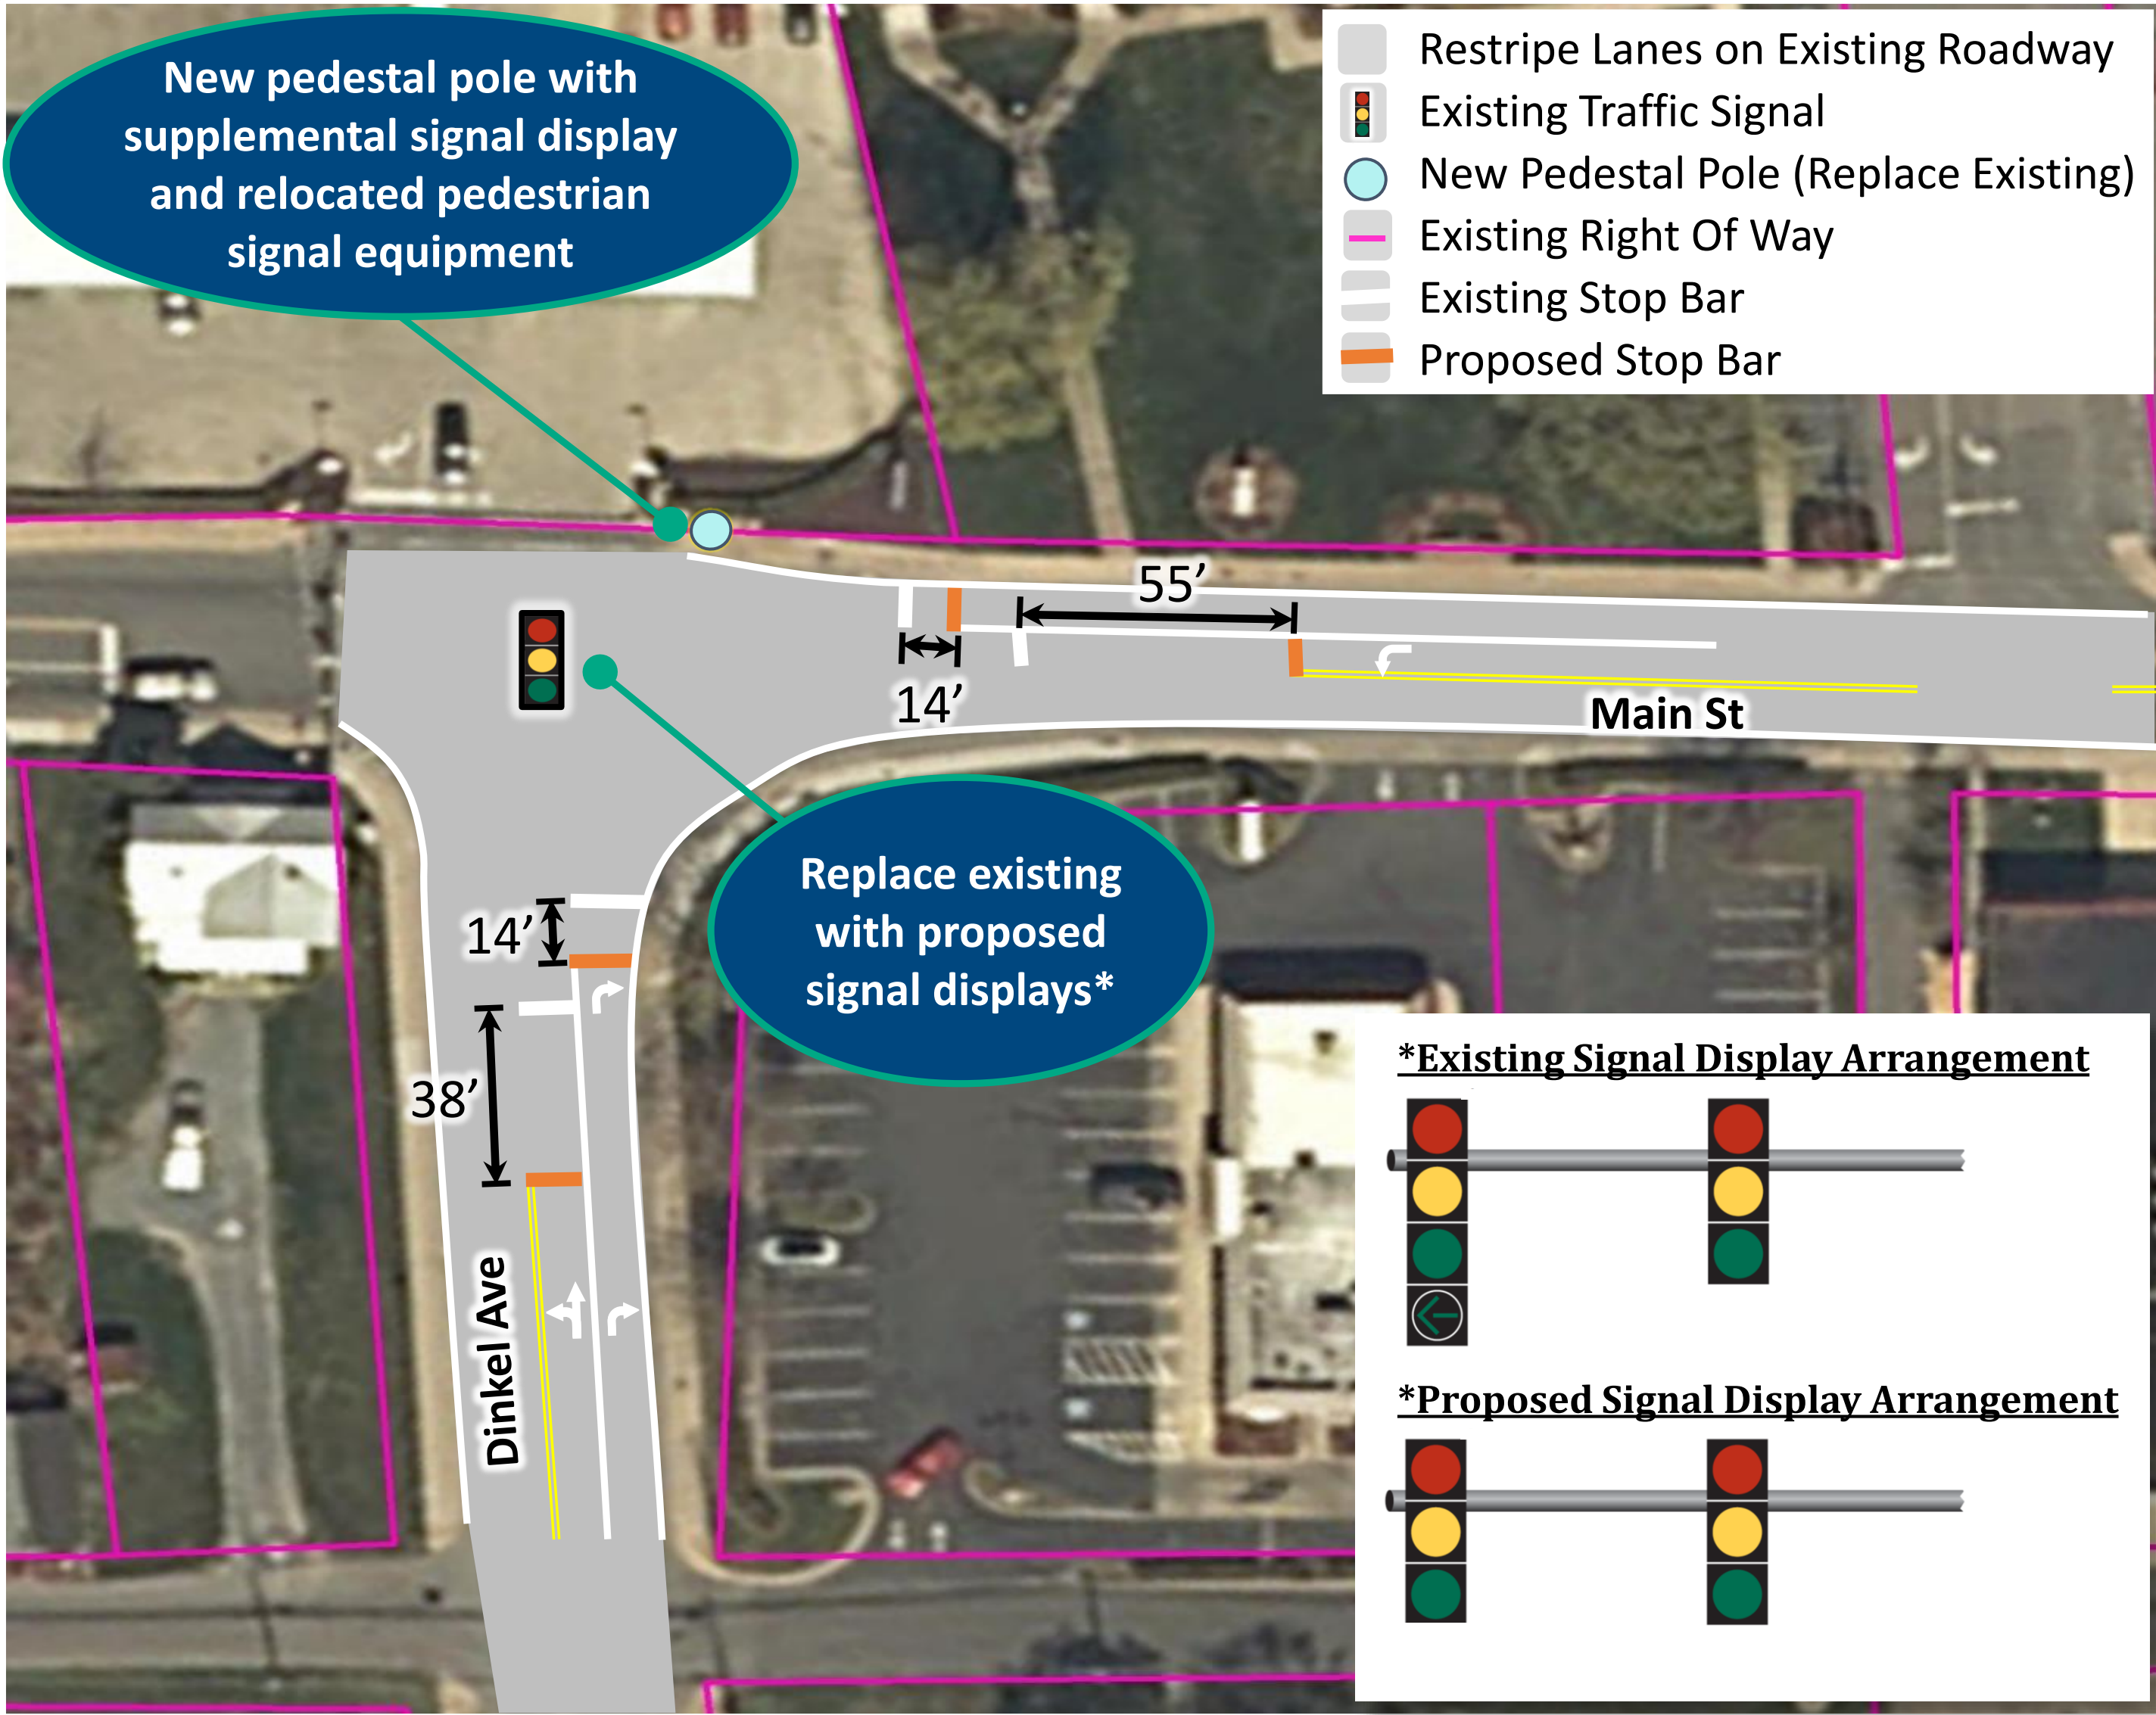
Vehicle Paths for Turning Trucks at Dinkel Avenue (shown in green)
